Application Bulletin

Hospital Discovers Cure for Chronically Dirty Cooling Towers

Addendum to Application Bulletin AB-209

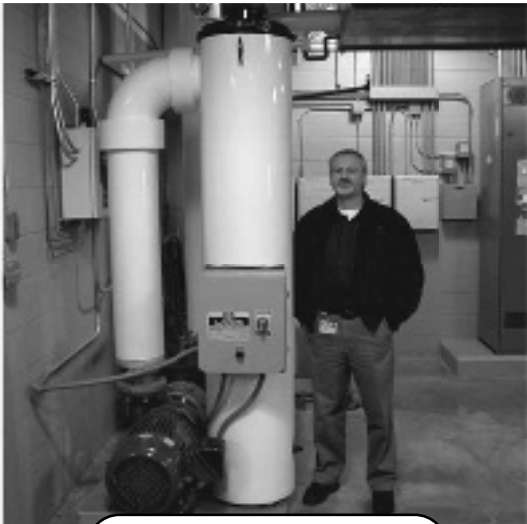
Central Plant Manager
Ray Smith and the LAKOS
TowerClean System

Shortly after Smith’s visit to OSU, a LAKOS TowerClean system was installed in the chiller plant at Deaconess, one floor below the cooling towers. The unit incorporates a unique basin sweeping system that continuously cleans the cooling tower basin by pulling water from the cold water basin and pumping it through the LAKOS centrifugal action separator to remove the solids (see photo). This clean water is reintroduced to the cold water basin under pressure through piping manifolds with induction producing spray nozzles, called HydroBoosters. This induced spraying action pushes the dirt away across the tower basin floor and away from the cooling tower condenser water return and towards the LAKOS system filtration suction point. The separator regularly purges the concentration of collected solids at specified intervals with discharge of the outlet flow into a purge metering box which helps balance the volume of purge fluids with the capacity of the floor drain to prevent flooding.
